## Campaign - Sunroof Drain Tube Extensions

Bulletin No.: 08207A

Subject:  
08207A - Sunroof Water Leak - Install Drain Tube Extensions

Models:  
2008 Buick Enclave  
2007-2008 GMC Acadia  
2007-2008 Saturn OUTLOOK

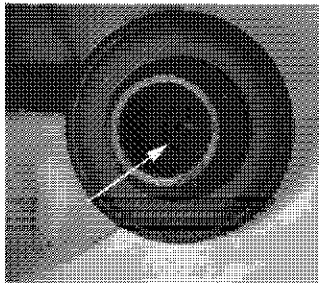
2. Remove the rubber grommet at the end of the drain tube.

3. Using a light-duty X-Acto knife, carefully remove the cross hatch inside the grommet and reinstall. Another solution is to utilize a 3/8 in spot weld drill bit to remove the cross hatch.
