Technical Service BULLETIN

DOOR CHECK POPPING NOISE

'04 – '06 Sienna

REVISED
NV003-07
NVH

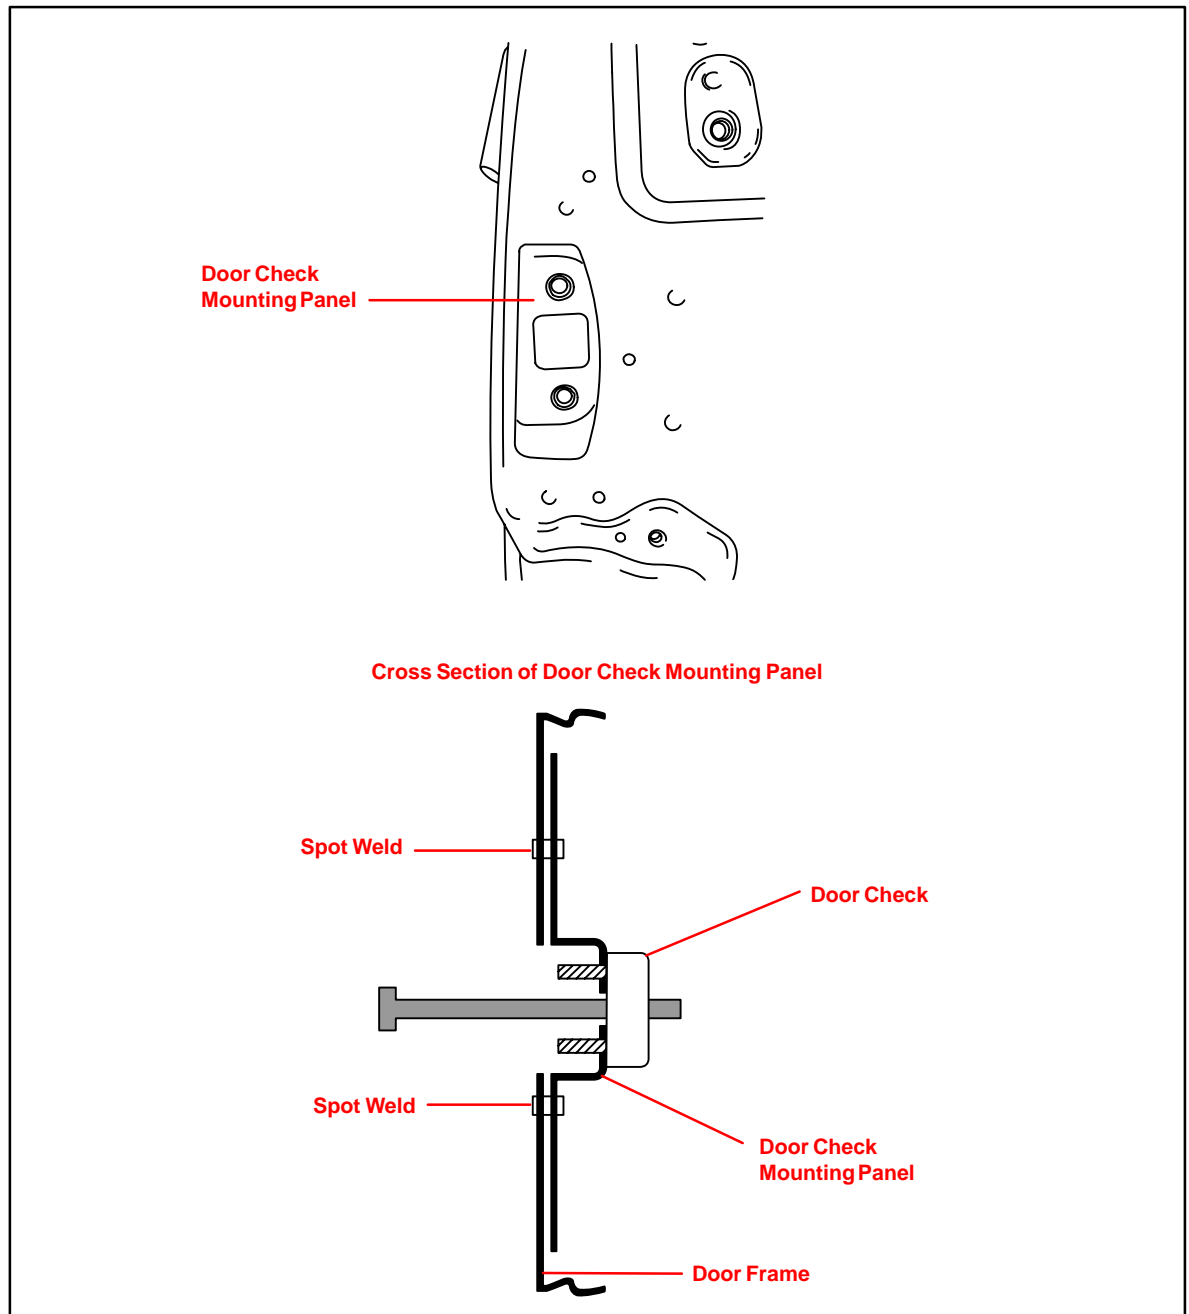
1. Confirm that a spot weld has separated by pushing on the door check mounting panel. If the panel can be pushed in by hand, the weld is loose.

2. At the spot weld, drill an 8.0-mm (0.32-in.) hole through the door frame ONLY.

3. Fill the drilled area using a MIG welder to connect all panels.
4. Use an appropriate color touch up paint on the welded material.
