#04-07-30-034: Service Engine Soon (SES) Light On, Diagnostic Trouble Code (DTC) P0741, Torque Converter Clutch (TCC) Excessive Slip, Transaxle Chuggle, Slip/Surge (Inspect/Replace Internal Transaxle Components) - (Aug 6, 2004)

Models: 1998-2002 Cadillac Eldorado
1998-2004 Cadillac Seville
1999-2004 Cadillac DeVille
2000-2003 Oldsmobile Aurora
with 4T80-E Auto Transaxle (RPO MH1)

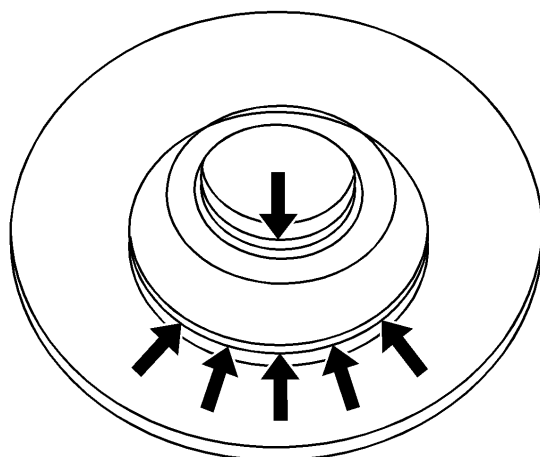
5. Inspect the two case cover seals (34 and 35) for uneven wear patterns.

10. Replace only the necessary internal transaxle components per the tear down inspection. See the parts list below.

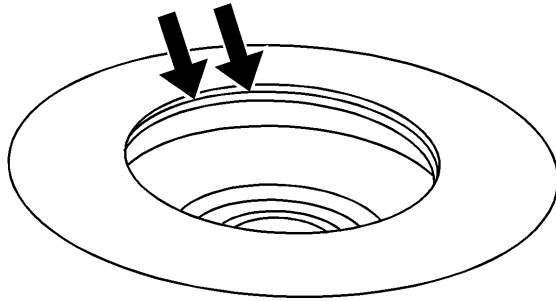
6. Inspect the two case cover seals (34 and 35) for uneven wear patterns. The wear patterns will be evident by a uneven wear pattern of the inner diameter white seal surface as shown in the two above illustrations.

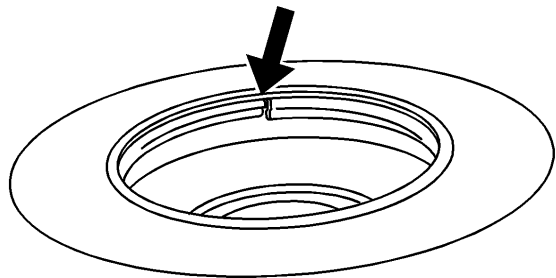
7. Inspect the two case cover seals (34 and 35) for splits/tears and or flat spots.

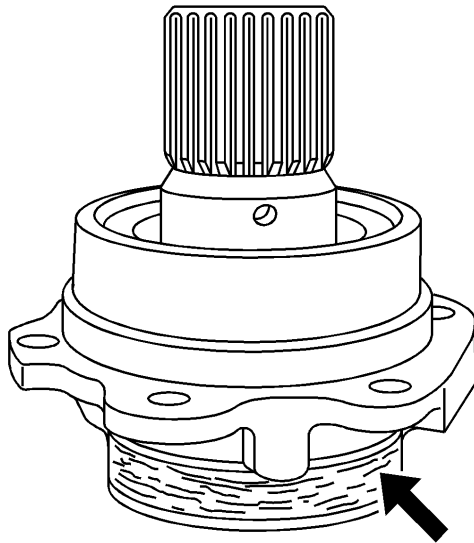
8. Inspect the support drive socket (400) for wear on the bearing race.
9. Inspect the case cover (33) for wear or damage due to the drive sprocket bearing spinning in the bore.
